## STABILITY ANALYSIS OF THE BUTTAHATCHEE RIVER BASIN, MISSISSIPPI AND ALABAMA

USDA-ARS National Sedimentation Laboratory Report Number 50

**Mississippi Department of Environmental Quality**

**November 2005**

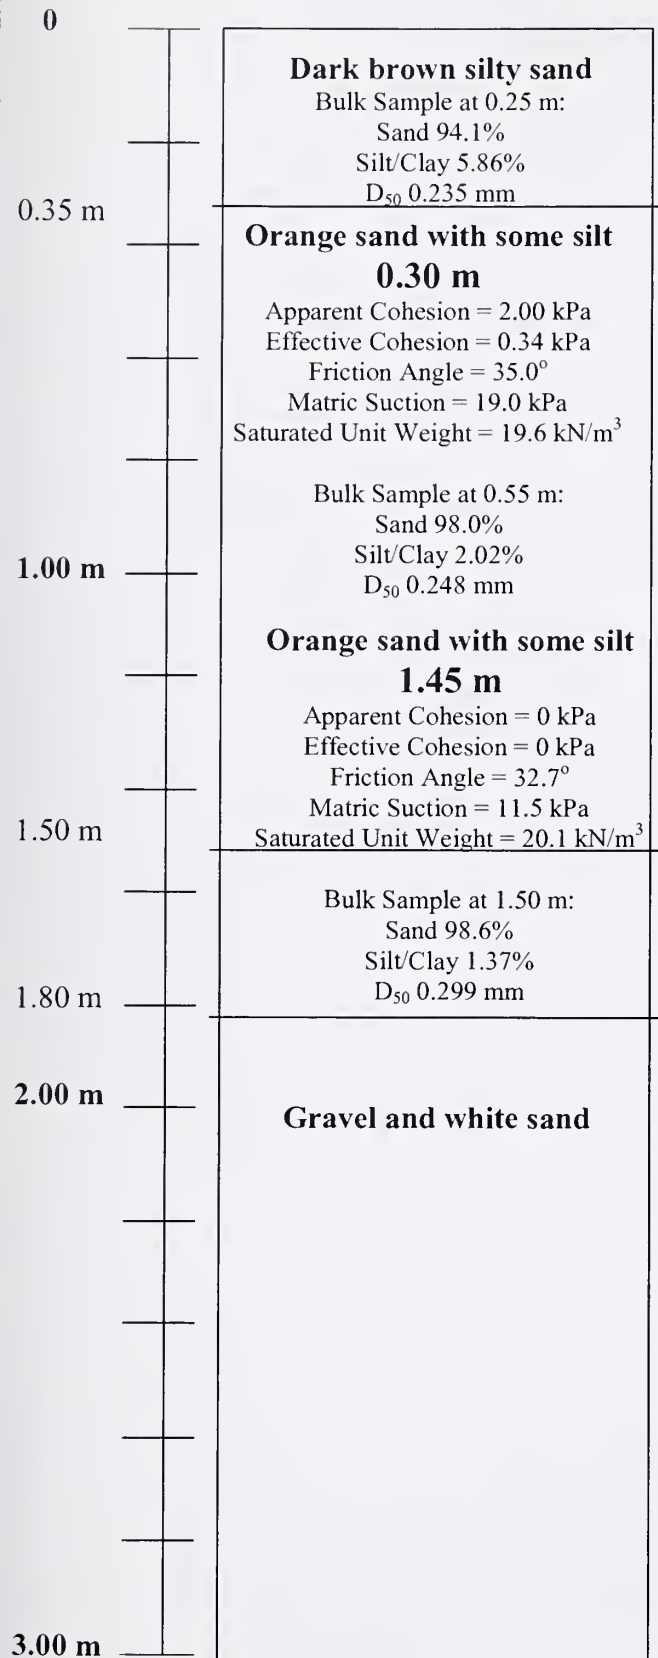
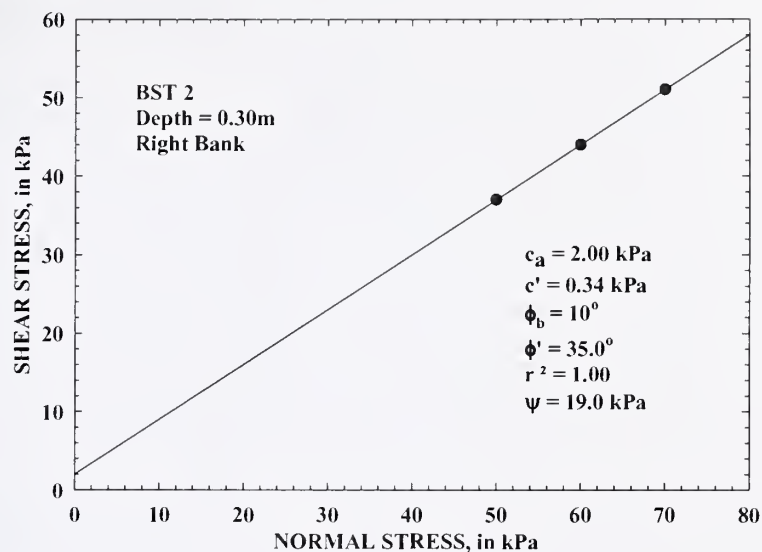
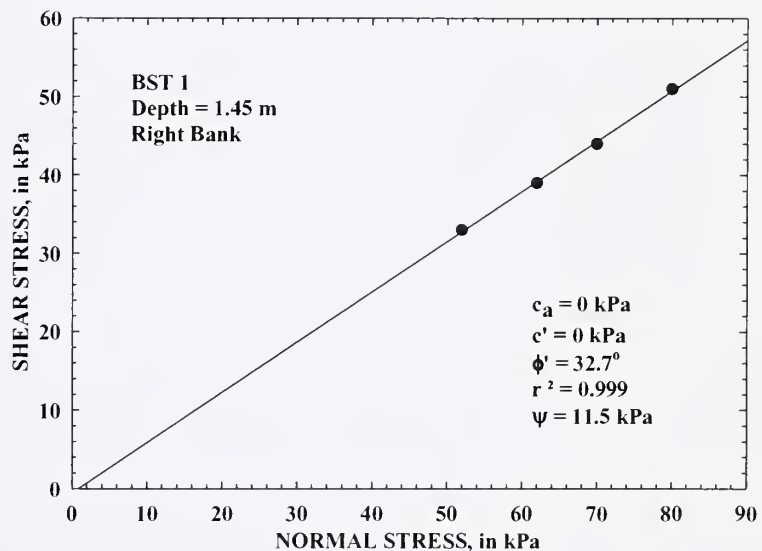
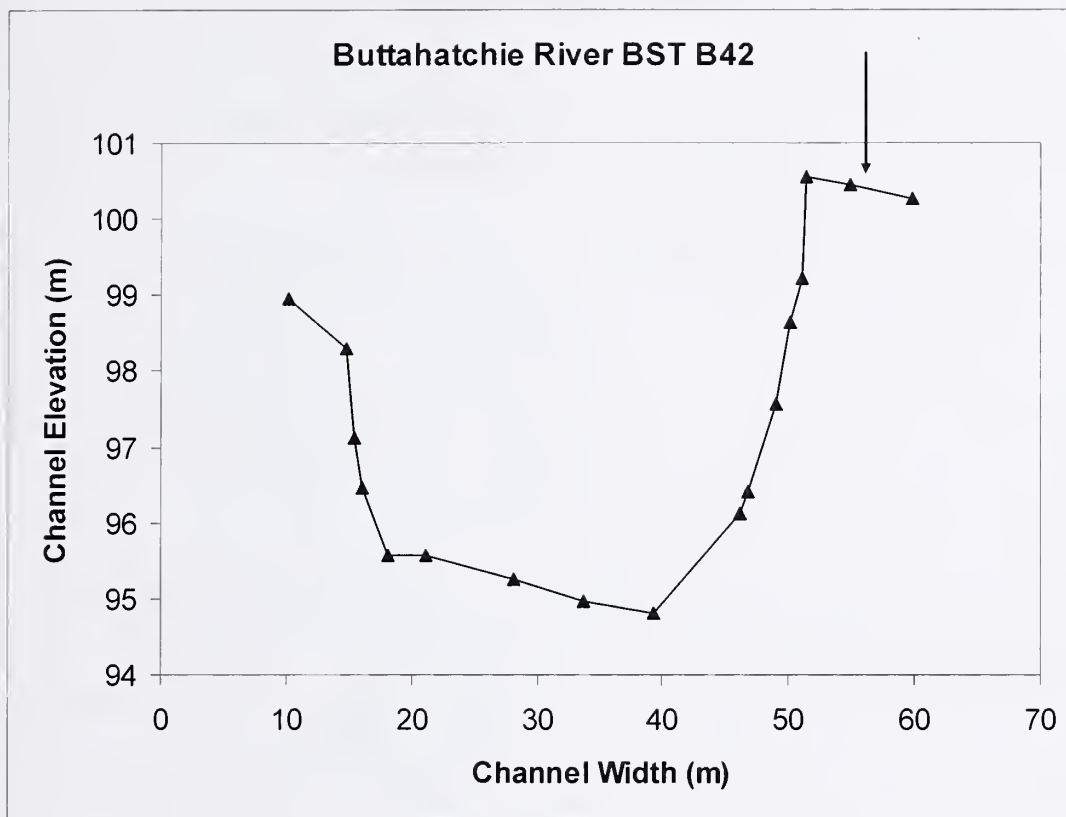
# B42 Right Bank

The bank stability results indicate that the banks tested at sites A28 and B42 were either conditionally stable or unstable under the widest range of flow and water table conditions. Indeed, for these two banks, the only times that banks were predicted to be stable were under high flow conditions at which time the confining pressure from the flow provides a stabilizing force to the bank. The upper part of the A28 bank profile was predominantly sand, containing some gravels and a small proportion of clay. High apparent cohesion in the uppermost layer (10.0 kPa, 0 - 0.36 m) decreased in the second layer as gravel and sand content increased. The bank layer at the base of the bank was dominated by gravel and sand, providing little cohesive support to the bank and a layer susceptible to undercutting by hydraulic forces.

Increasing the relative stability of these banks is a matter of decreasing bank angles and thereby decreasing the driving forces, or conversely, increasing the resistance of the banks to mass failure. This can be accomplished by protecting the bank toes from hydraulic erosion and undercutting using rock or other materials that deflect flow or by increasing the geotechnical strength of the banks. The latter option can sometimes be accomplished by the planting of riparian vegetation, which provides reinforcement through the establishment of a root-soil matrix.

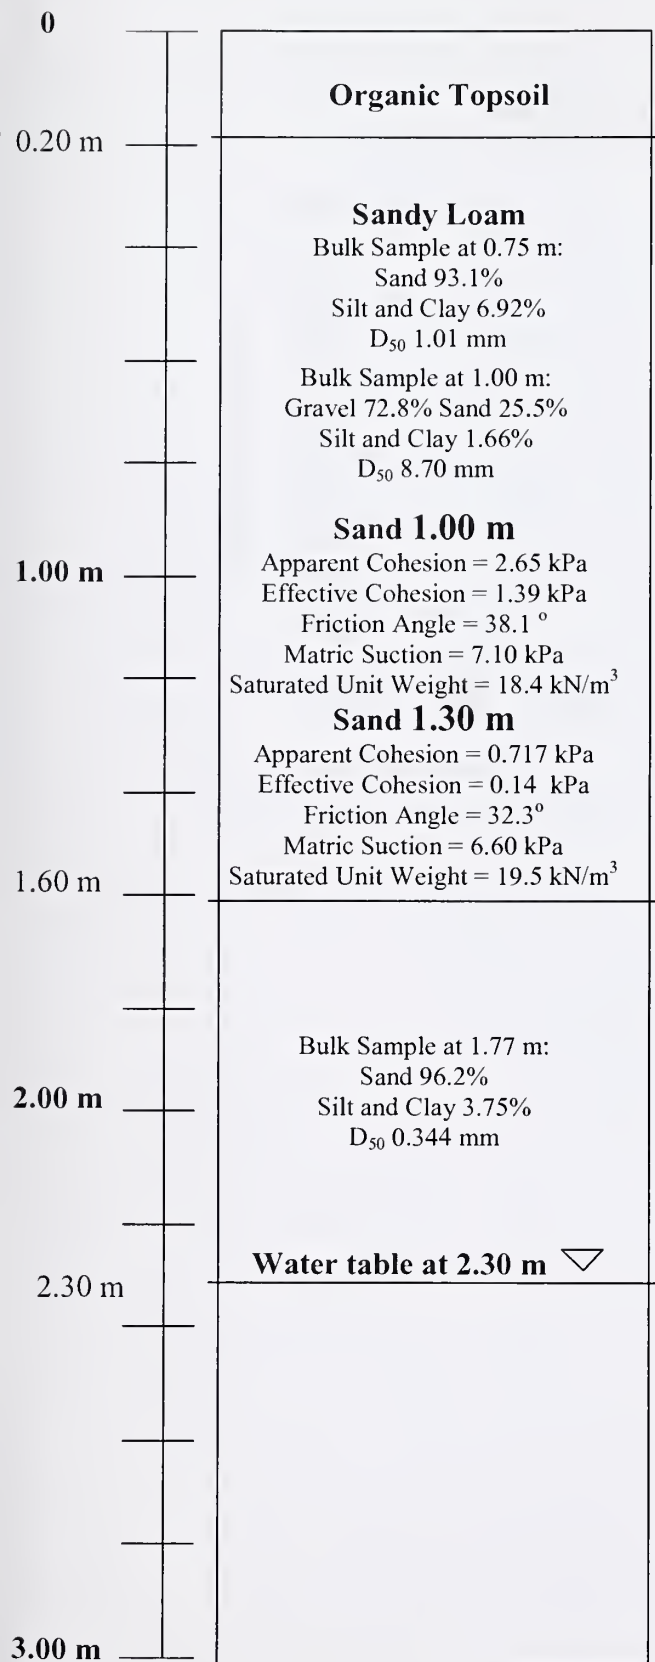
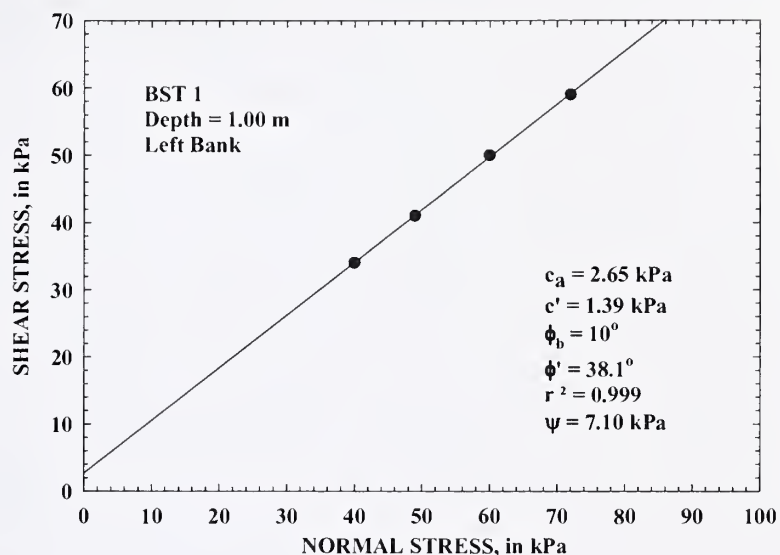
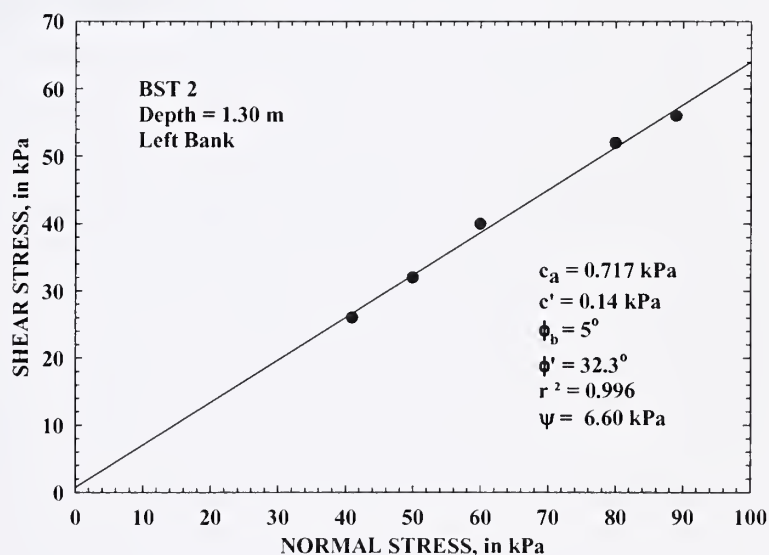
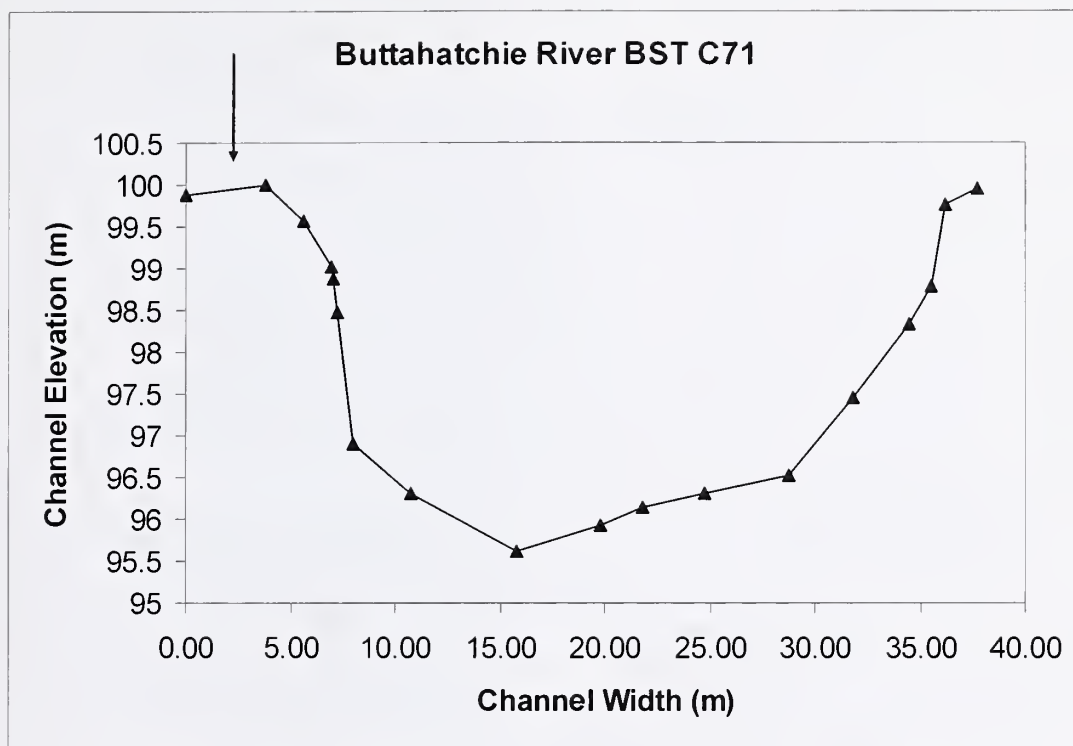
## C71 Left Bank

The banks tested at A10, C71 and D88 were generally found to be stable, until water table heights rose to 75 % of the bank height, at which point bank resisting forces are decreased sufficiently by the generation of pore-water pressures, for bank failures to occur even under high flow conditions. Only at 95 % bankfull flow depths does the confining pressure from flow overcome the decreased resistance from saturation and decreased resistance of the bank material from the higher water table.

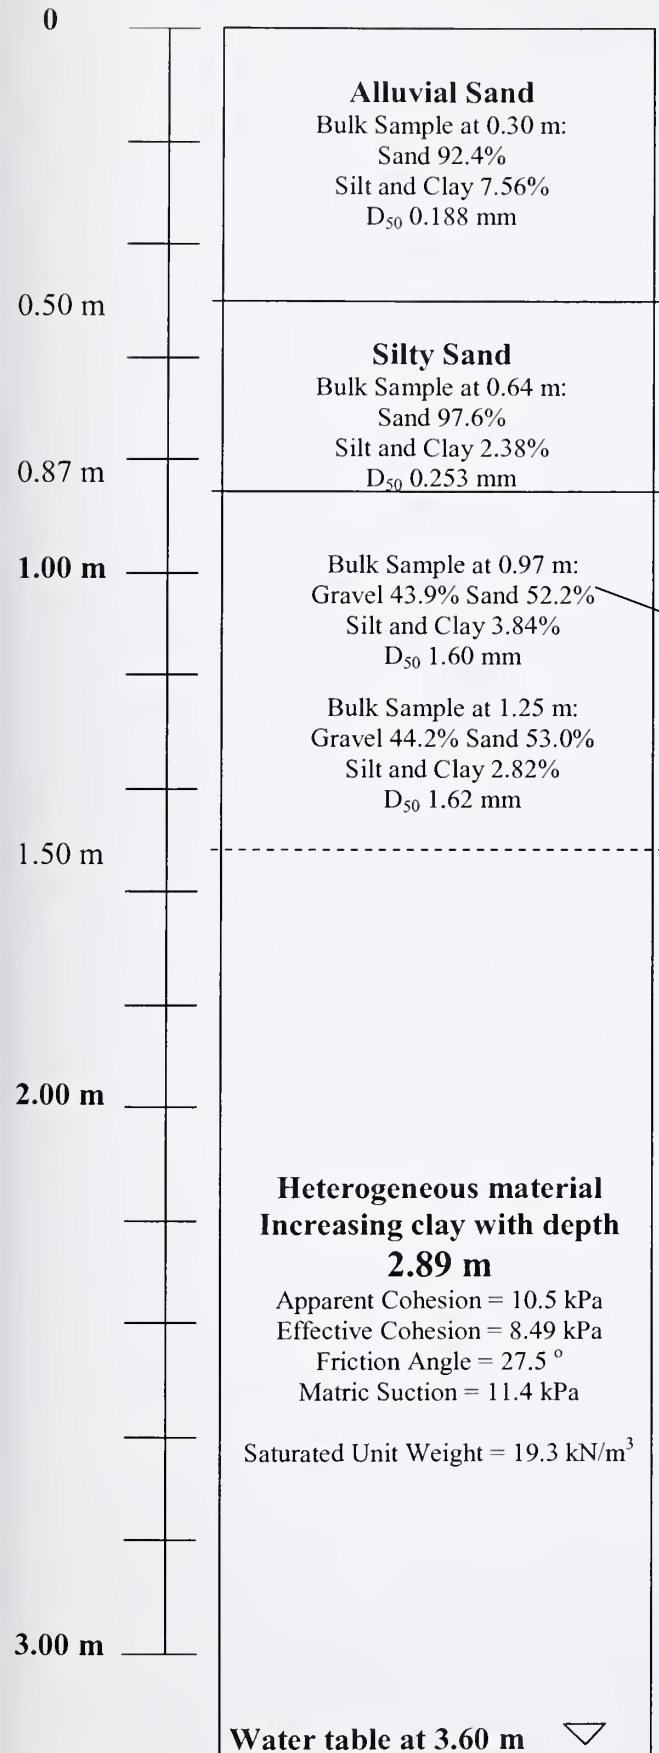
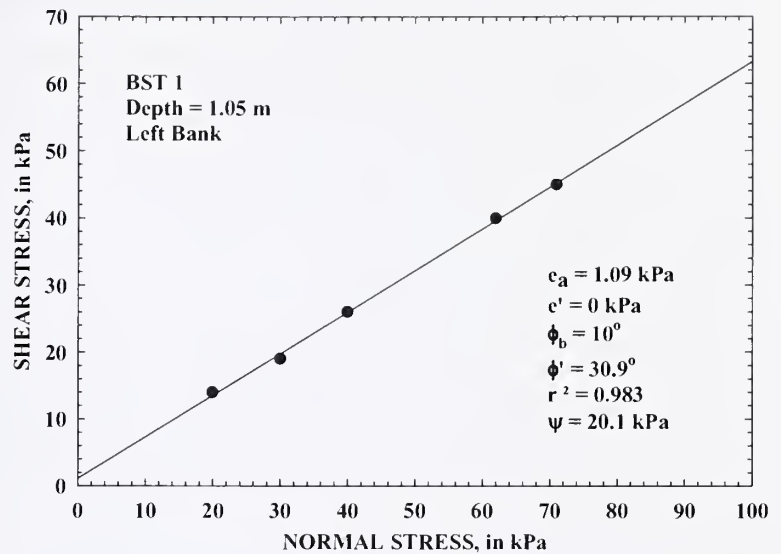
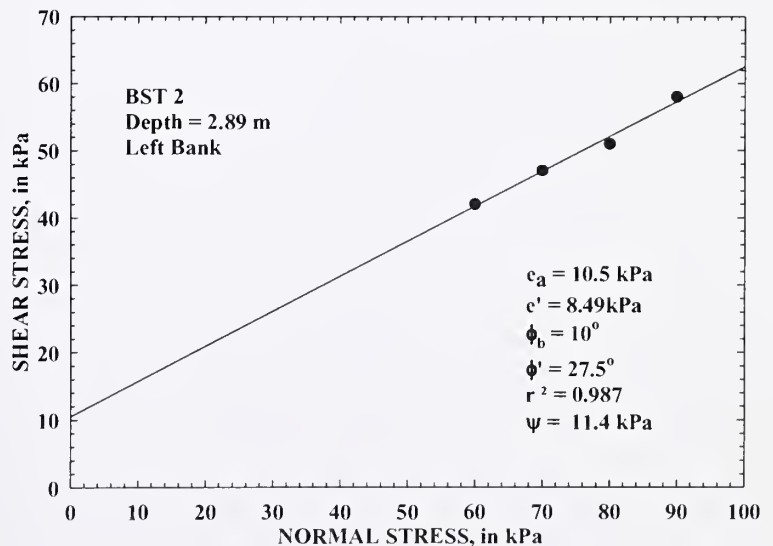
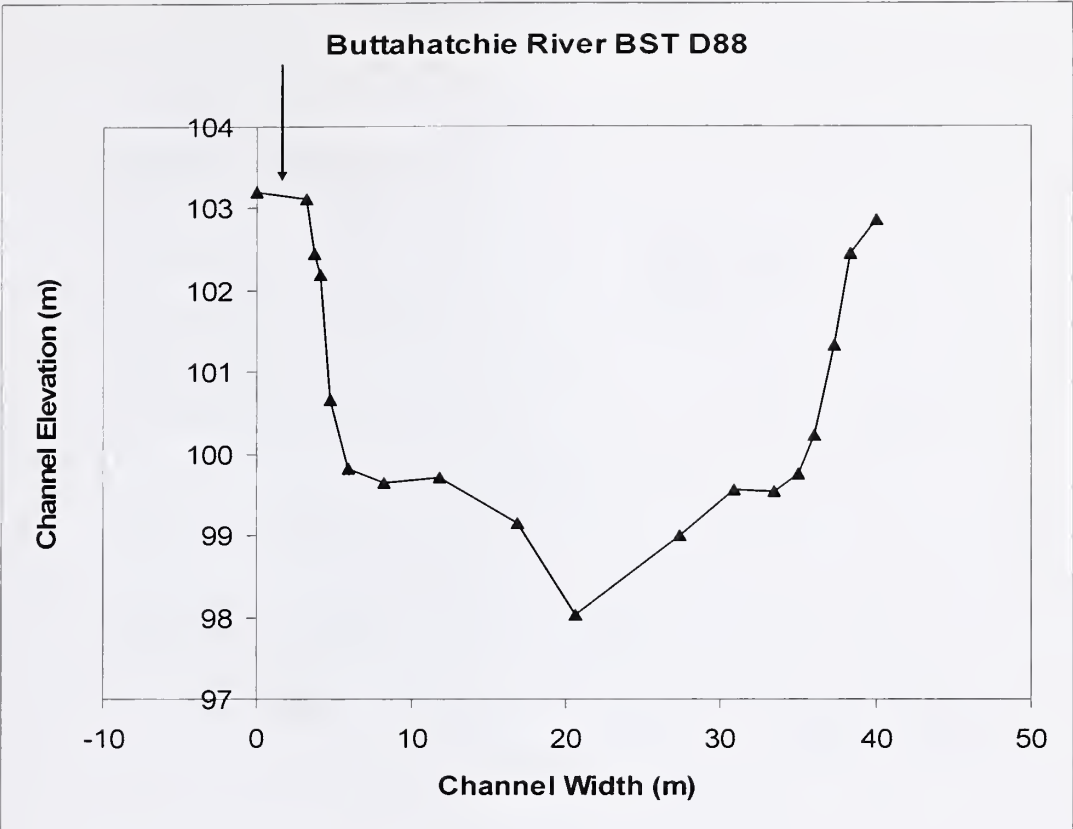
## D88 Left Bank

**Brown heterogeneous**  
**Sandy gravel**  
**1.05 m**

Apparent Cohesion = 1.09 kPa  
Effective Cohesion = 0 kPa  
Friction Angle =  $31.8^\circ$   
Matric Suction = 18.9 kPa

Saturated Unit Weight =  $18.1 \text{ kN/m}^3$

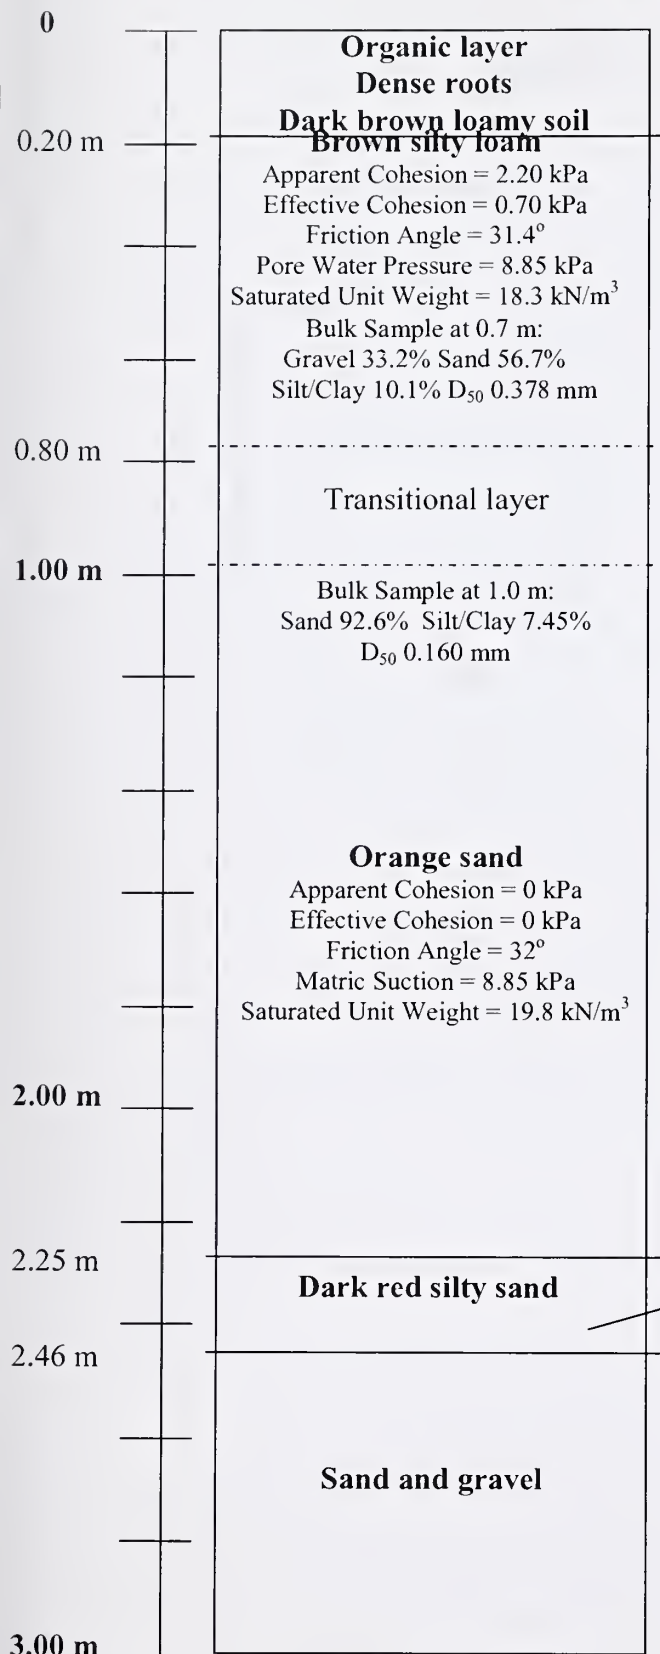
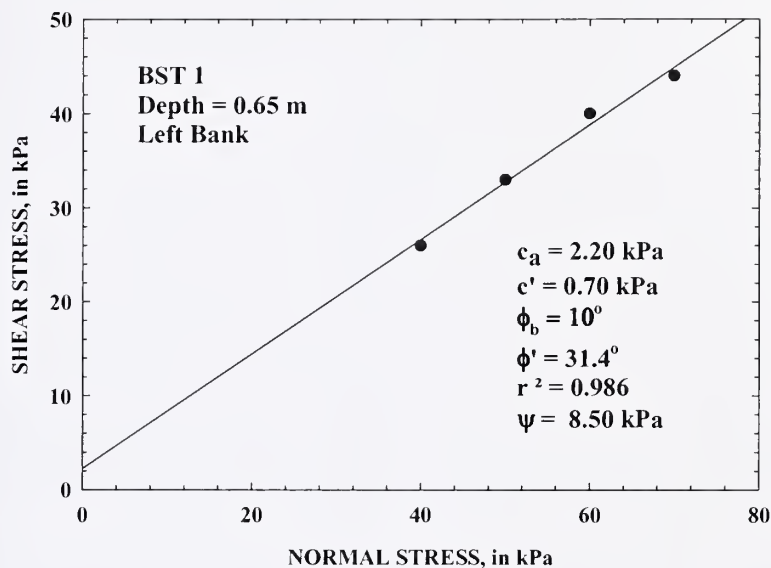
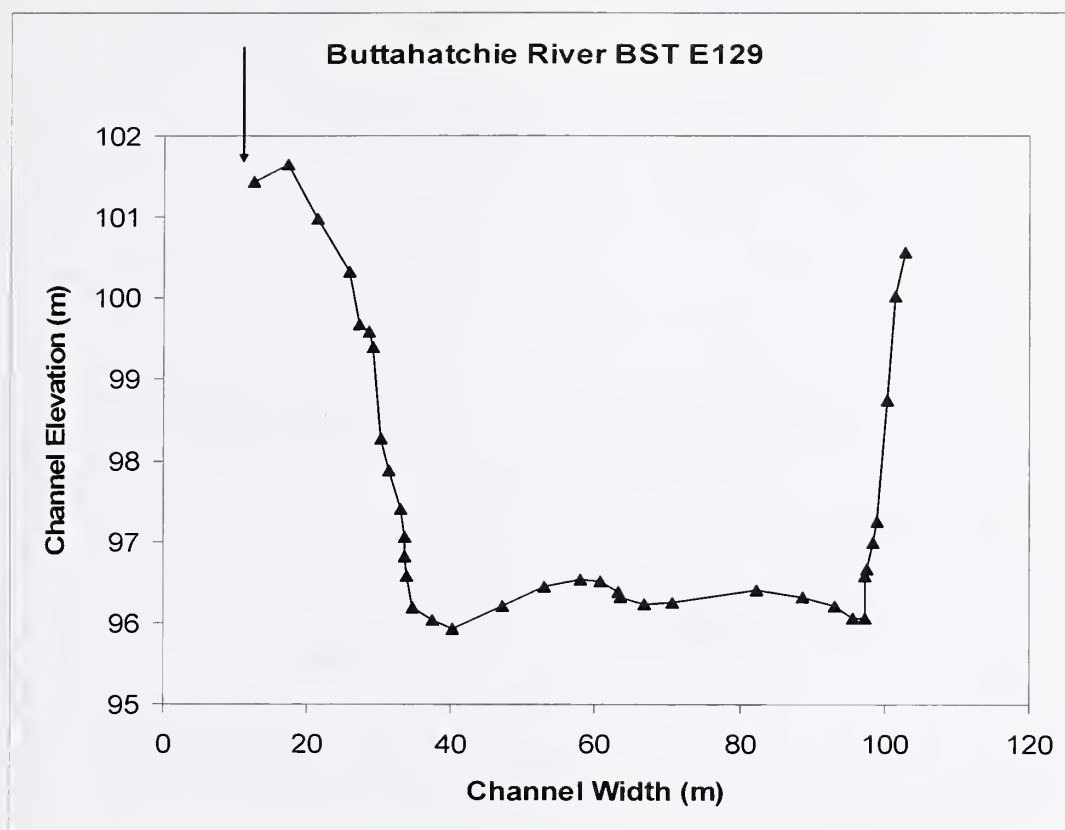
## E129 Left Bank

Bulk Sample at 2.25 m:  
 Gravel 31.1% Sand 67.0%  
 Silt/Clay 1.83%  $D_{50}$  0.530 mm
